Project: Kelburn Normal School

Seismic Assessment of School Hall

Prepared for: Ministry of
Education

19 February 2013

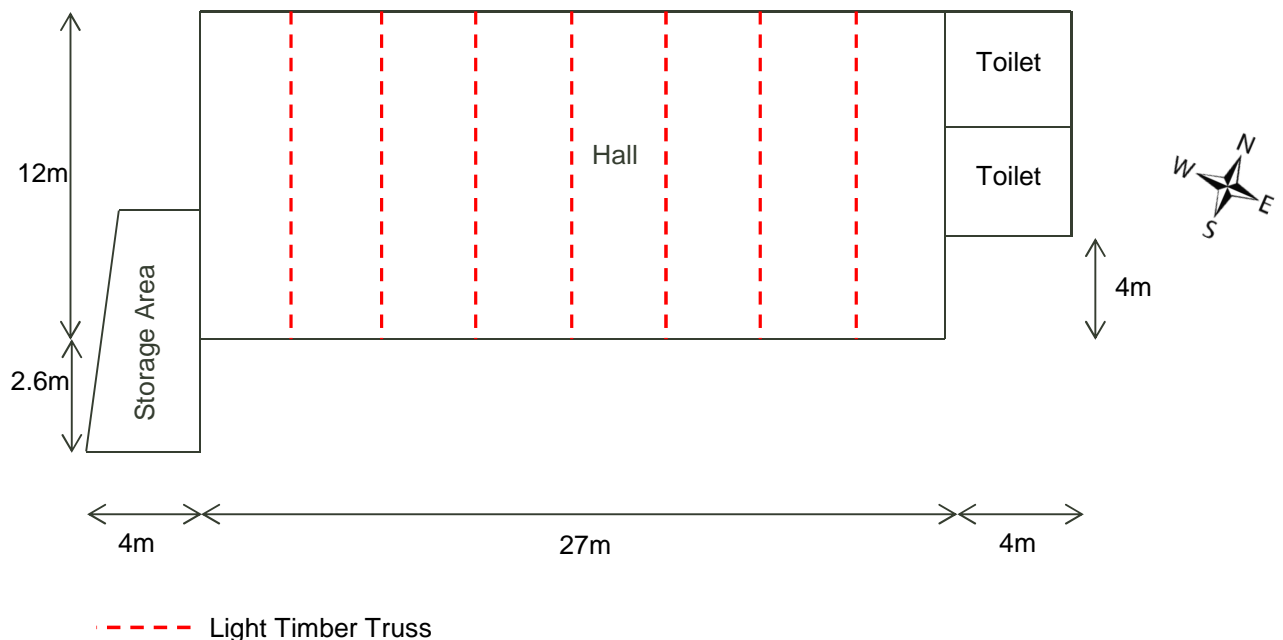
Figure 2 – School Hall Floor Plan

In the longitudinal direction seismic loads are resisted by a combination of wall studs in bending, braced partially by particleboard, and softboard lined shear walls. In the transverse direction seismic loads are resisted by the moment resisting timber trusses spaced evenly throughout the Hall as shown in Figure 2.

It was found that the lateral bracing elements in the School Hall are able to resist **21%** and **41%** of the current building code requirements in the longitudinal and transverse directions respectively. This is governed by the softboard lined upper half of the walls and strength of supporting timber columns.

To increase the bracing capacity of the walls it will be necessary to either install a higher capacity wall lining or replace some existing windows with effective wall. By replacing the current linings with Gib Braceline and upgrading the wall hold-downs it may be possible to increase the lateral capacity of the School Hall to above 100% of current building code requirements without losing any window space.

The capacity of the moment resisting timber truss is limited by the moment capacity of the supporting columns. The capacity of the columns could be improved by adding additional full height timber members alongside the existing.
